CTS Report: TS1004.2 (version for public release)
July, 2015 (original version submitted April 2015)

Insurance Claims Data Analysis for Cyclones Yasi and Larry

Report prepared by:
Daniel Smith and David Henderson
Cyclone Testing Station, JCU

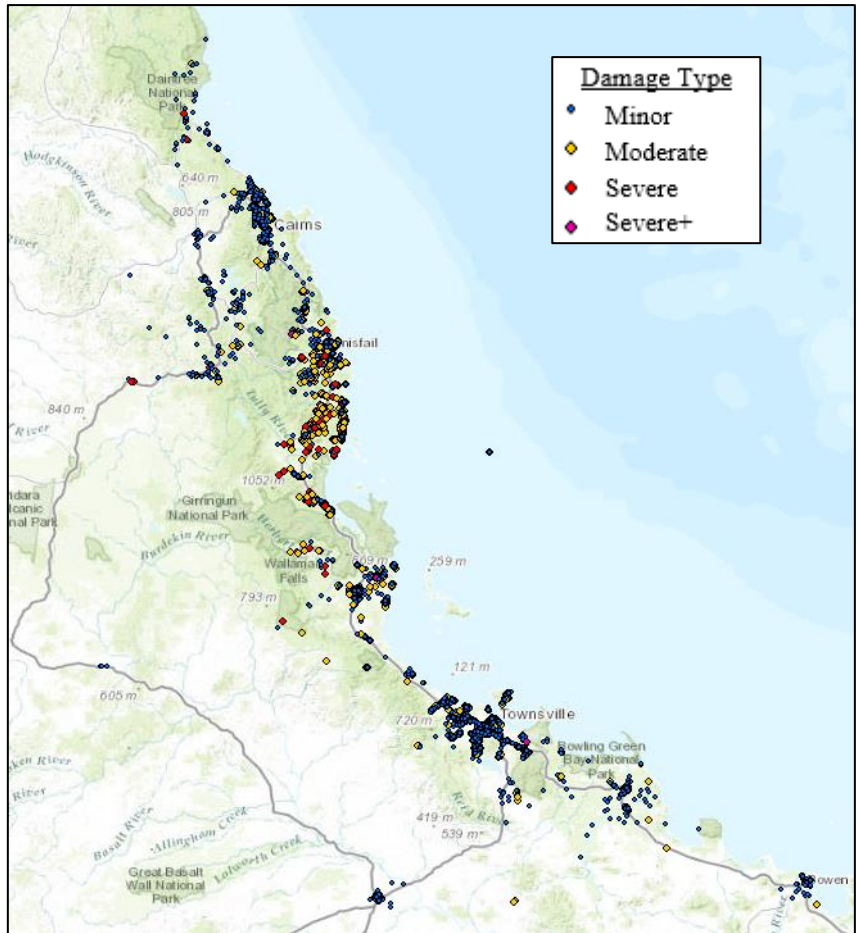
Figure 1. Northern Queensland Coastal Region impacted by Cyclone Yasi and selected for analysis including the distribution of damage types

Figure 1 shows the spatial distribution of properties falling within the four non-zero loss ratio bins (i.e. policies with claims) for the Northern Queensland Coastal Region. Figure 2 shows the estimated track for Cyclone Yasi and Figure 3 shows the estimated wind field near the point of landfall. As expected, loss ratios increase directly with wind speed. The frequency of large loss ratios (i.e. large claims) was greatest, in locations nearest the point of landfall (i.e. Cardwell, Mission Beach, etc.) where wind speed estimates were 210-240 km/h. However, claims were filed across the entire North Queensland region, even in areas of significantly lower wind speed (i.e. ~135 km/h in Townsville, ~90 km/h in Cairns).

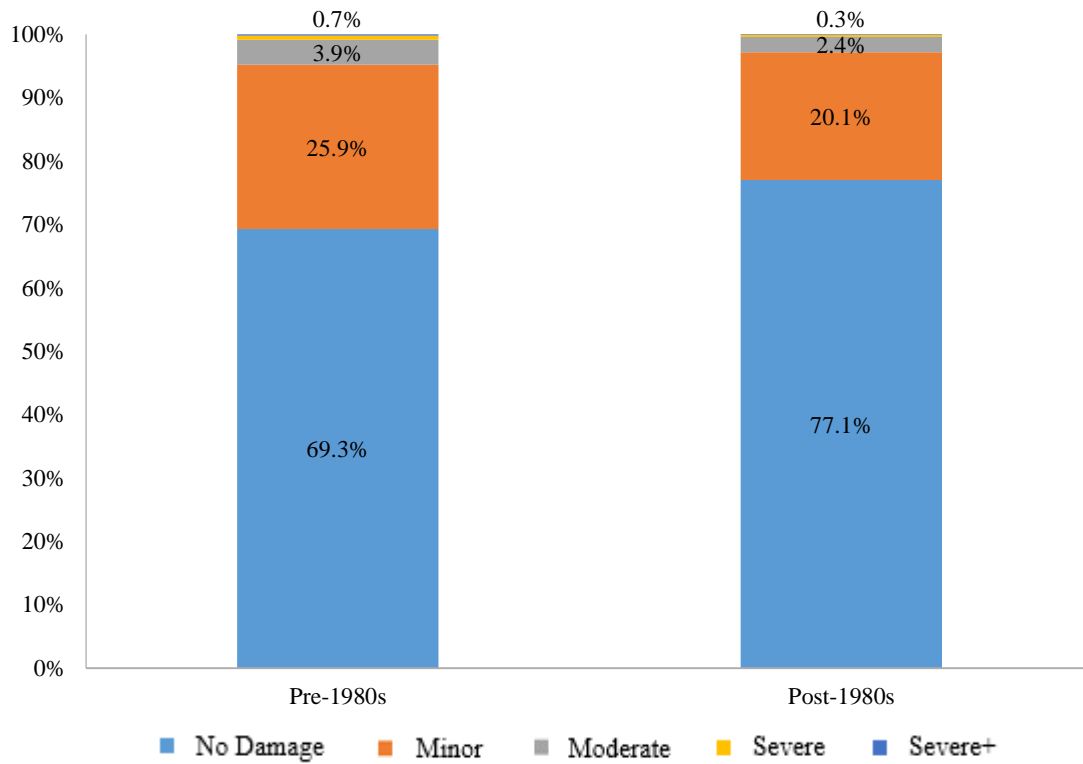
Figure 9. Building age vs damage type contributions (pre- and post-1980s) to the total number of claims filed in relation to Cyclone Yasi for the North Queensland Coastal Region (note: “Severe+” bin proportions are less than 1% each and omitted from this figure for clarity)

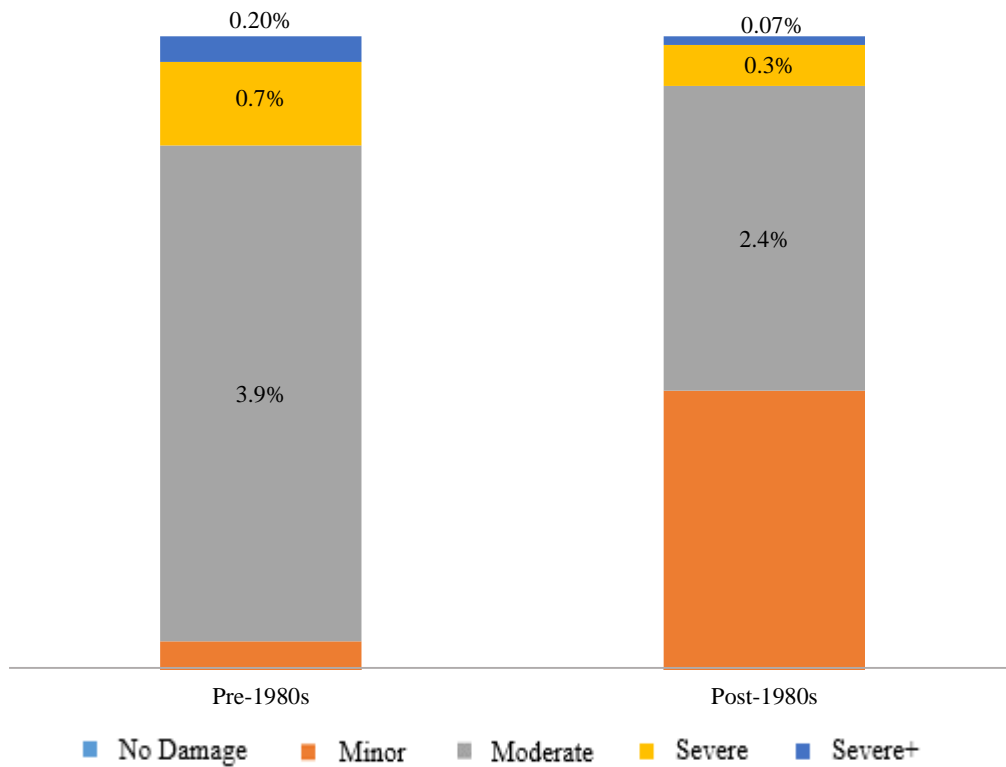
Figure 10. Building age vs damage type contributions (pre- and post-1980s) to the total number of claims filed in relation to Cyclone Yasi for the North Queensland Coastal Region (Note: This figure is a magnified view of higher intensity damage types in Figure 9 per Suncorp request)

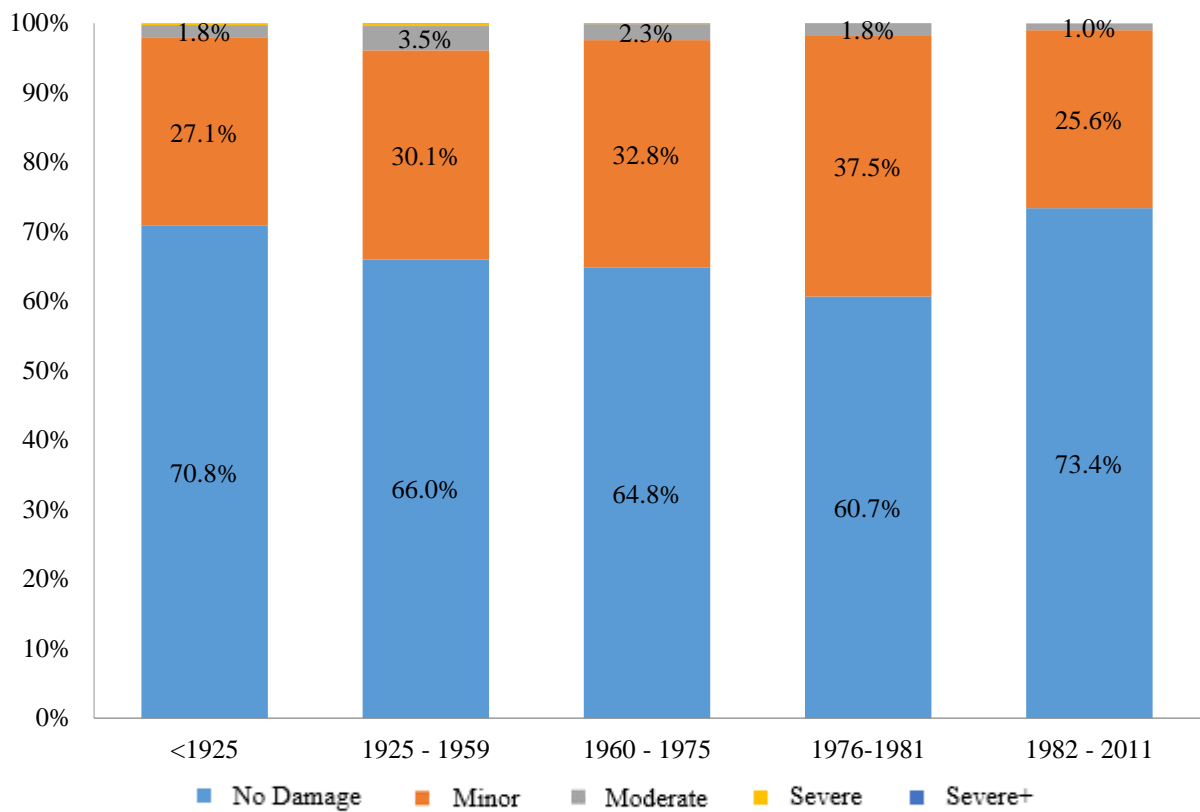
Figure 11. Building age vs damage type contributions to the total number of claims filed in relation to Cyclone Yasi for the Townsville Region (note: “Severe” and “Severe+” bin proportions are less than 1% each and omitted from this figure for clarity)

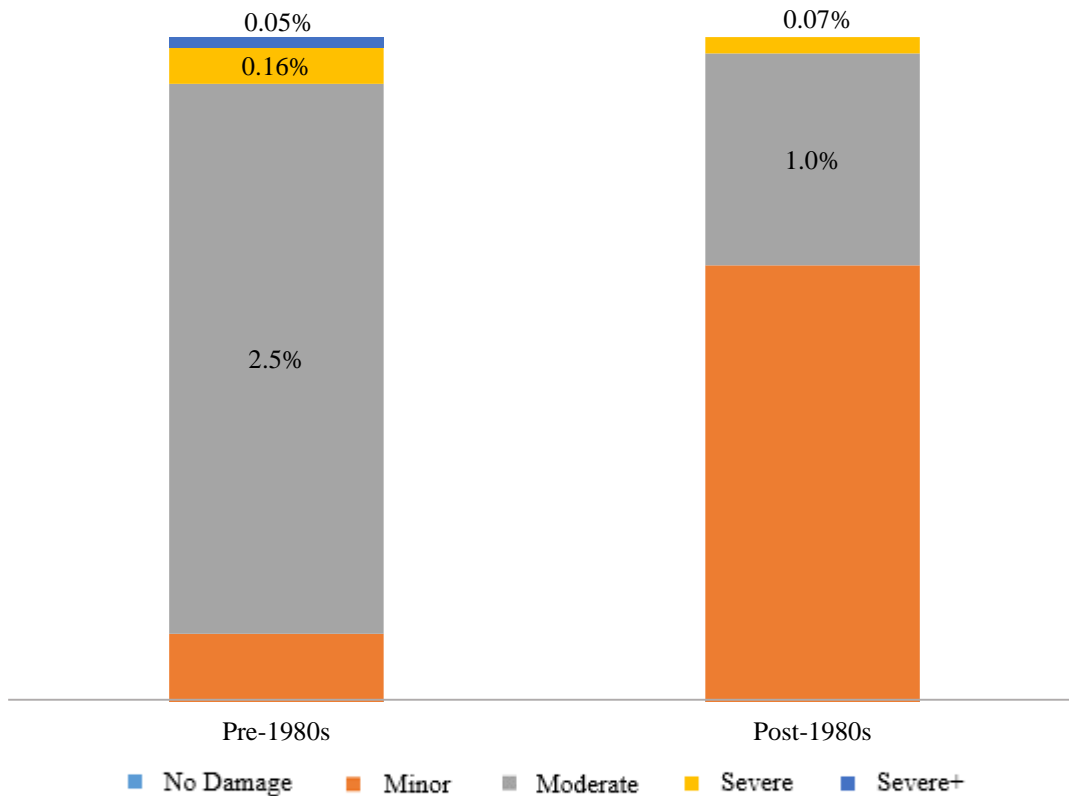
Figure 14. Building age vs damage type contributions (pre- and post-1980s) to the total number of claims filed in relation to Cyclone Yasi for the Townsville Region (Note 2: This figure is a magnified view of higher intensity damage types in Figure 13 per Suncorp request)

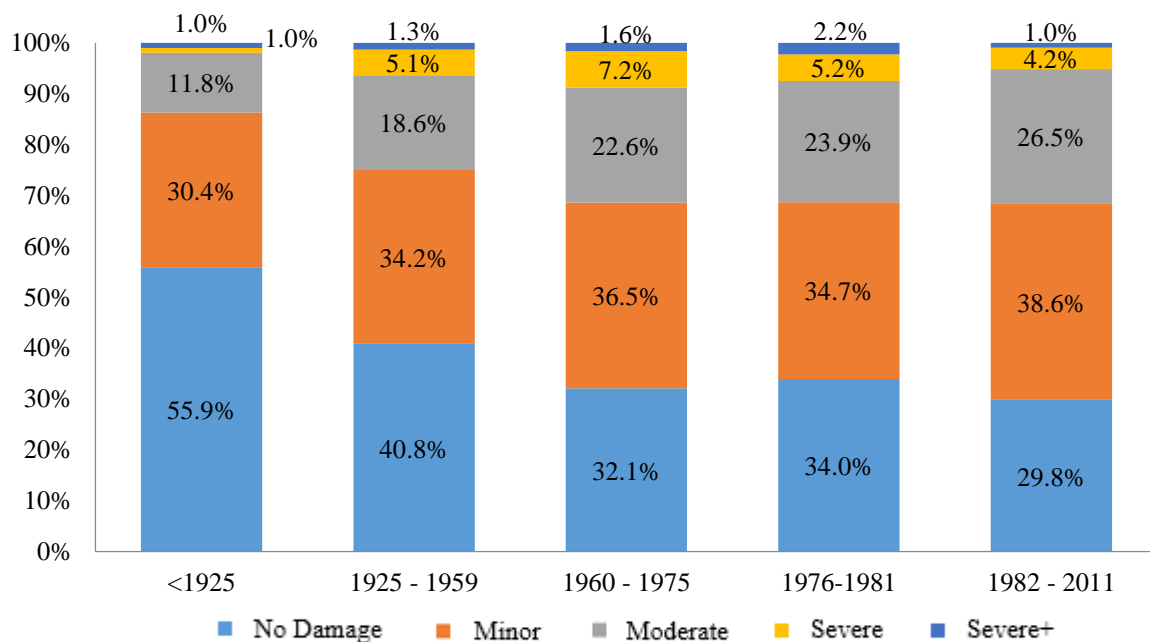
Figure 15. Building age vs loss ratio bin (see legend) contributions to the total number of claims filed in relation to Cyclone Yasi for the Tully/Mission Beach Region (note: “Severe” and “Severe+” bin proportions are less than 1% each and omitted from this figure for clarity)

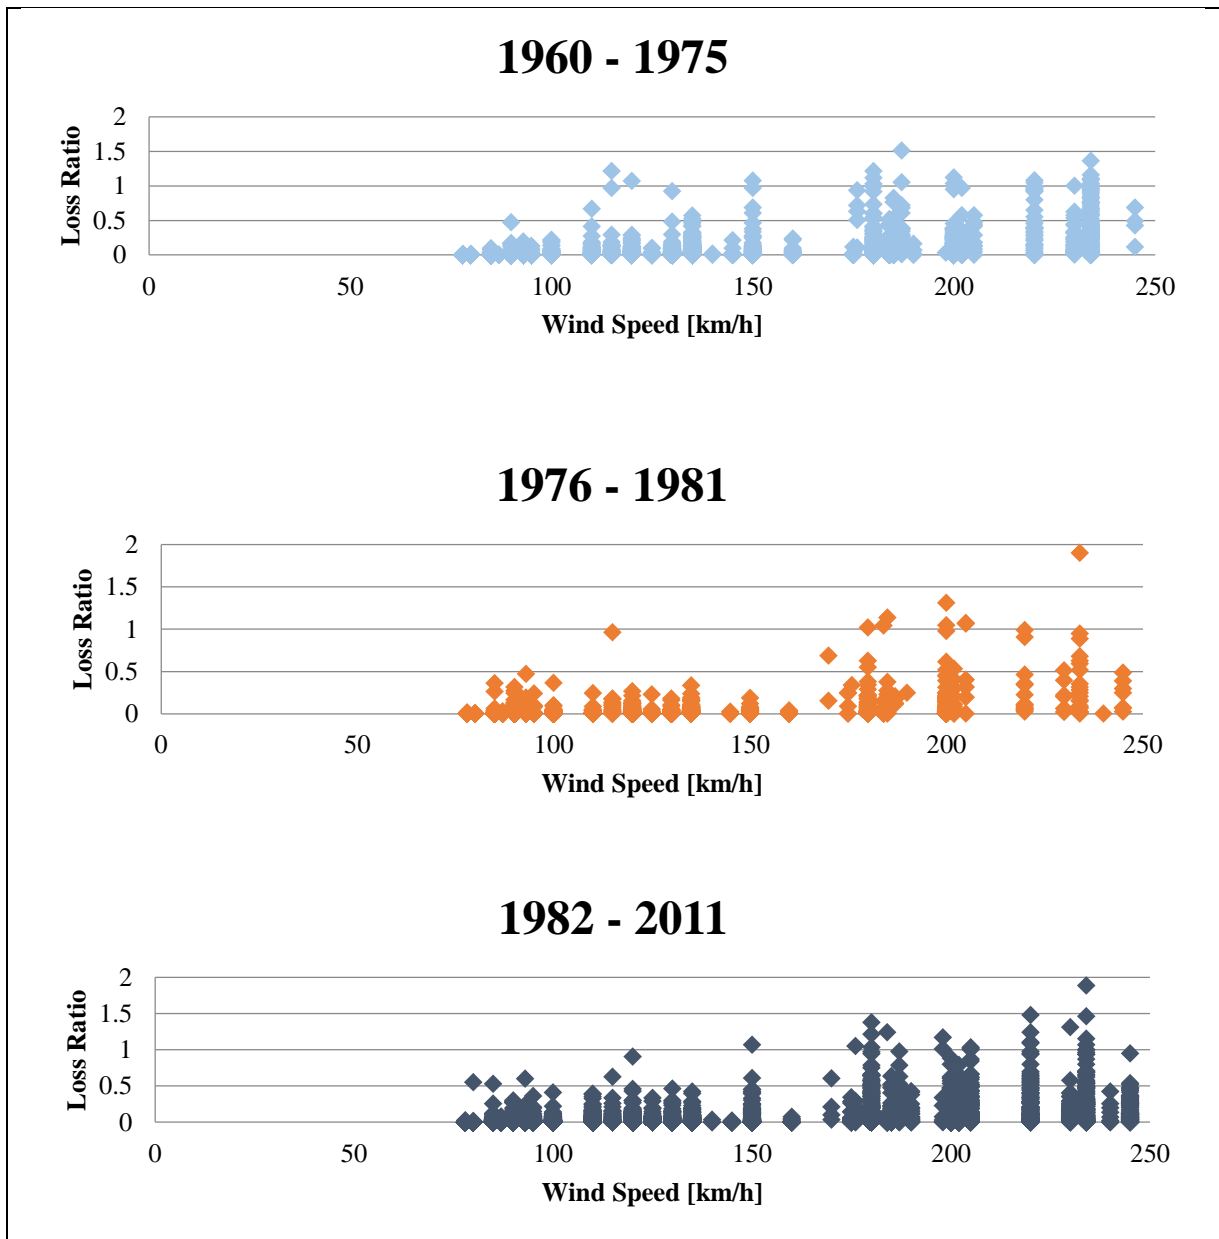
Figure 18. Loss ratio vs wind speed grouped by age for all claims in the North Queensland Coastal Region

Design wind speed in the North Queensland Coastal Region is 240 km/h. Engineering requirements for housing constructed after 1982 are designed to ensure structural stability, minimised local damage and loss of amenity, and avoid damage other properties. The high occurrence rate of large claims at wind speeds from 150-240 km/h for modern housing indicates that modern housing did not perform as predicted by the National Construction Code (NCC).

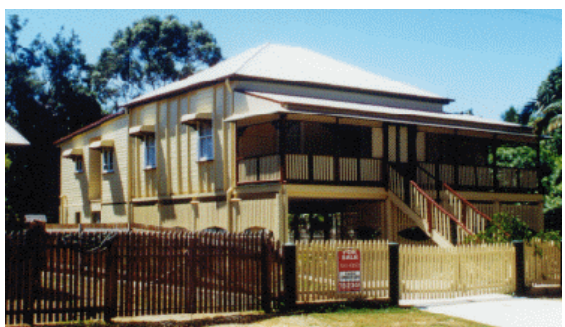
<p>Hip roof, reduced rafter spans, central core, exposed studs, on stumps (low and high)</p>
1925 – 1959

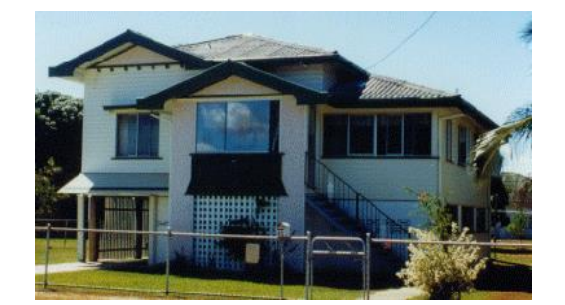
<p>Hip and gable, VJ lining, reduced rafter spans, on stumps (low and high)</p>
1960s – 1981

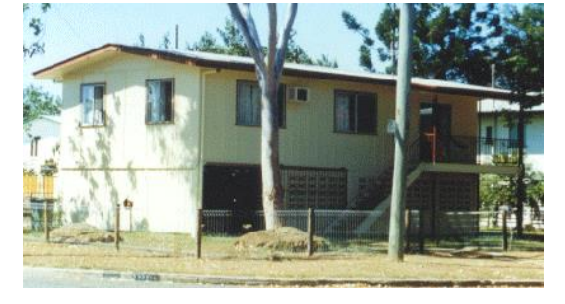
<p>Gable low pitch, vermin proof flooring (studs not mortice and tennon into bearers), panel cladding, on stumps</p>
1981 - present

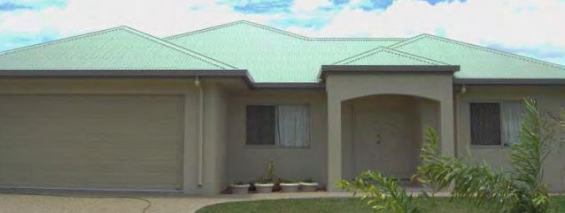
<p>Reinforced masonry block, hip and gable, large truss spans, medium roof pitch, slab on ground</p>
